EnviroGroup Limited  
*The environmental solutions company*

April 30, 1999

### Results of Perlite Analyses

Optical Microscopy Analysis  
Page 1 of 5

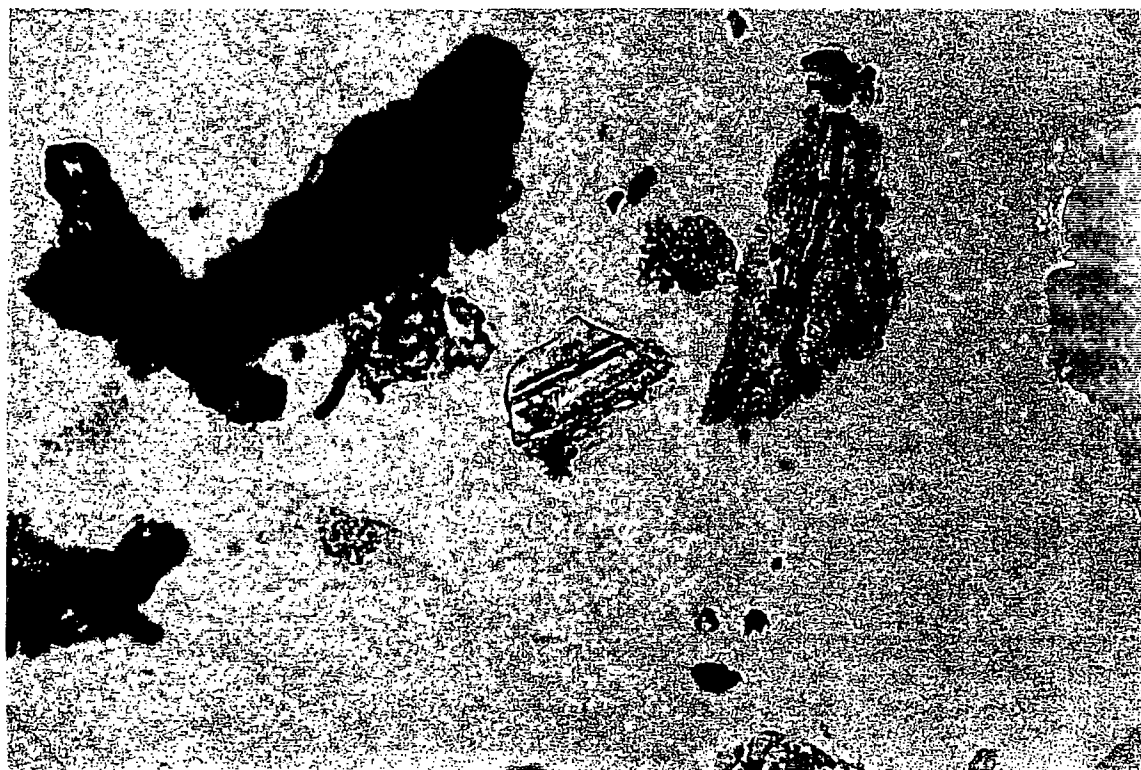
Photo 2 (44K05302Z): Glass shard showing characteristics of pumice. Uncrossed polarized light - 400X.

Client Sample No.: **44K05302Z**  
DCMSL Sample No.: EGL1-1

Sample no. 44K05302Z contained one glass fragment having characteristics similar to the pumice standard. The fragment is 40 $\mu$ m in size and completely isotropic. The refractive index is less than 1.550 and the fragment shows a channel-like morphology.

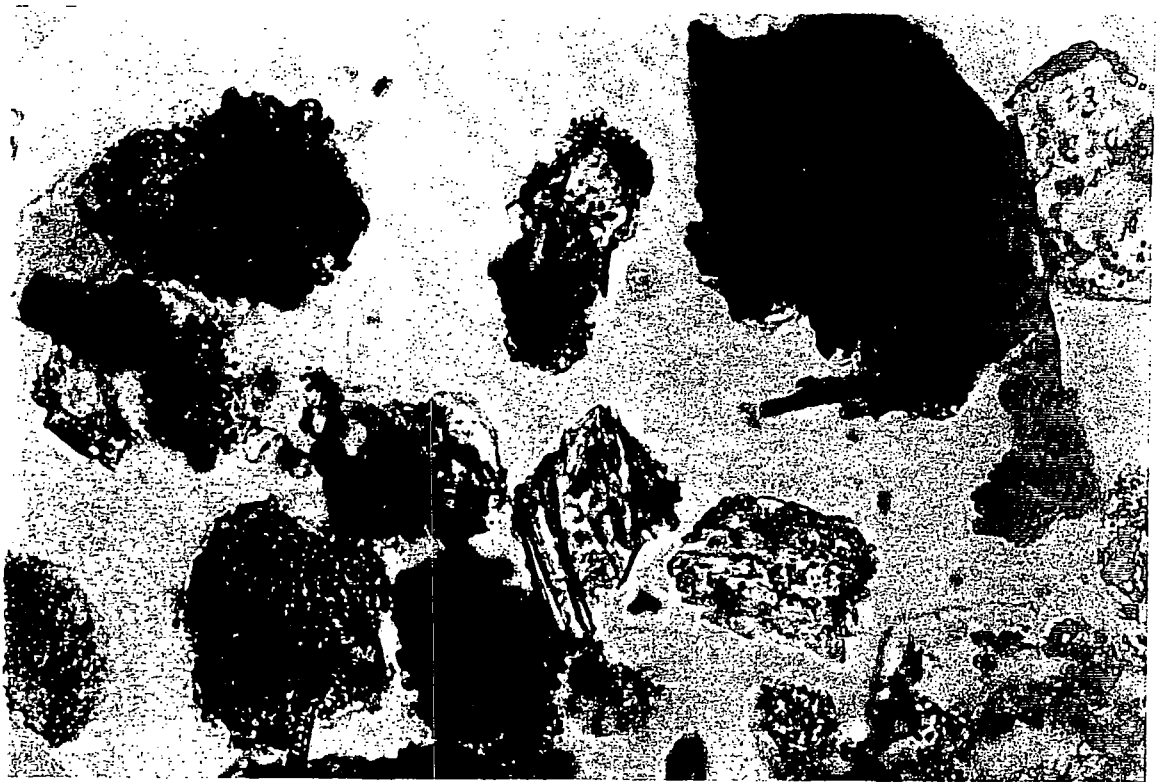
Photo 3 (44K05312Z): Glass fragment in the center with morphology like pumice. Uncrossed polarized light - 400X.

Client Sample No.: **44K05312Z**  
DCMSL Sample No.: EGL1-2

Sample no. 44K05312Z also contains a glass fragment with characteristics similar to the pumice standard. The fragment is sharp, colorless, channeled and perforated. The fragment is isotropic and 75 $\mu$ m in size with a refractive index of less than 1.550, similar to the pumice standard.

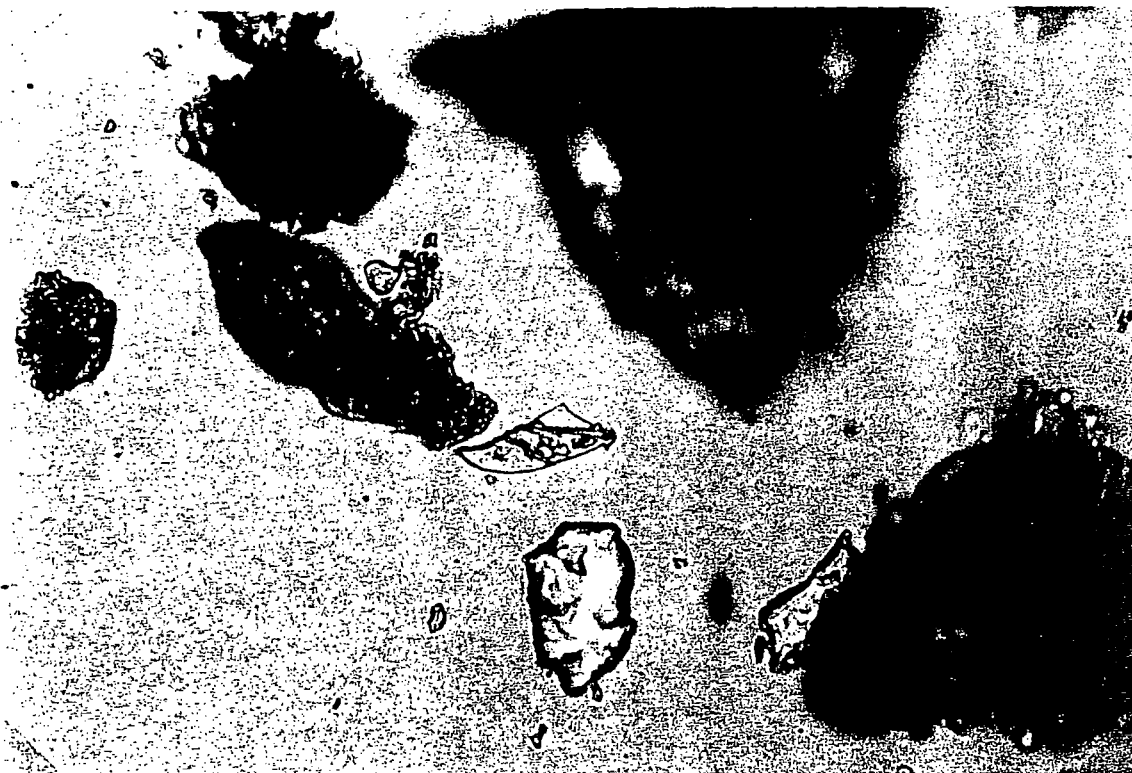
Photo 5 (44K06302Z): Small glass fragment in the center of the photo displays characteristics of perlite. Uncrossed polarized light - 400X.

Client Sample No.: **44K06302Z**

Sample no. 44K06302Z contains a small glass fragment 40 $\mu$ m in size that exhibits the same characteristics as the perlite standard. It is colorless and sharp with an irregular shape. The fragment is completely isotropic. The refractive index is less than 1.550, similar to the perlite standard.

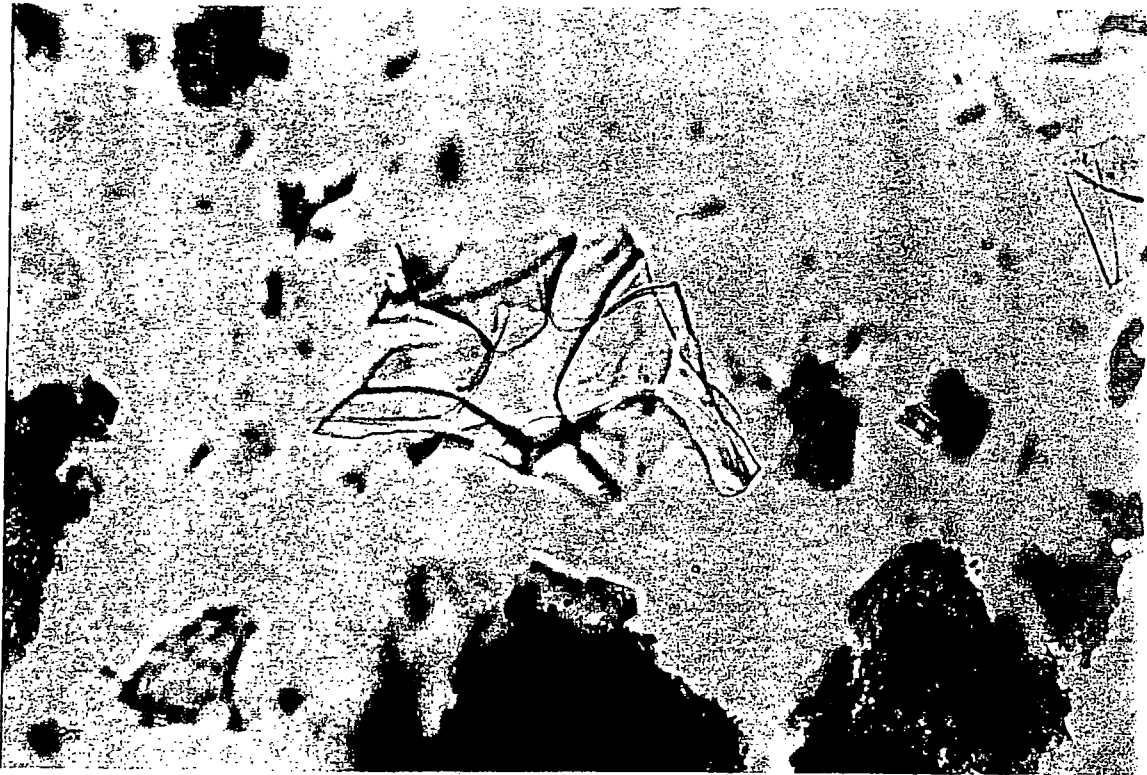
Photo 1 (45F23003A @ 29'): Perlite fragment measuring 100 $\mu$ m. Uncrossed polarized light - 400X.

Soil sample no. 45F23003A @ 29' contains two intact perlite grains. The grains are white in color, rounded in shape and have grain size measurements of 1mm to 3mm. Perlite glass fragments were also identified in the prepared grain mounts. The fragments range from 40µm to 100µm in size, have sharp, angular outlines and show channel-like features. The fragments are completely isotropic and have a refractive index lower than 1.550. These characteristics are consistent with the known perlite standard.
